National Register of Historic Places Inventory—Nomination Form

historic The Dagmar Hotel

street & number 50 Summit Avenue, at intersection of _____ not for publication

city, town Hagerstown _____ vicinity of _____ congressional district Sixth

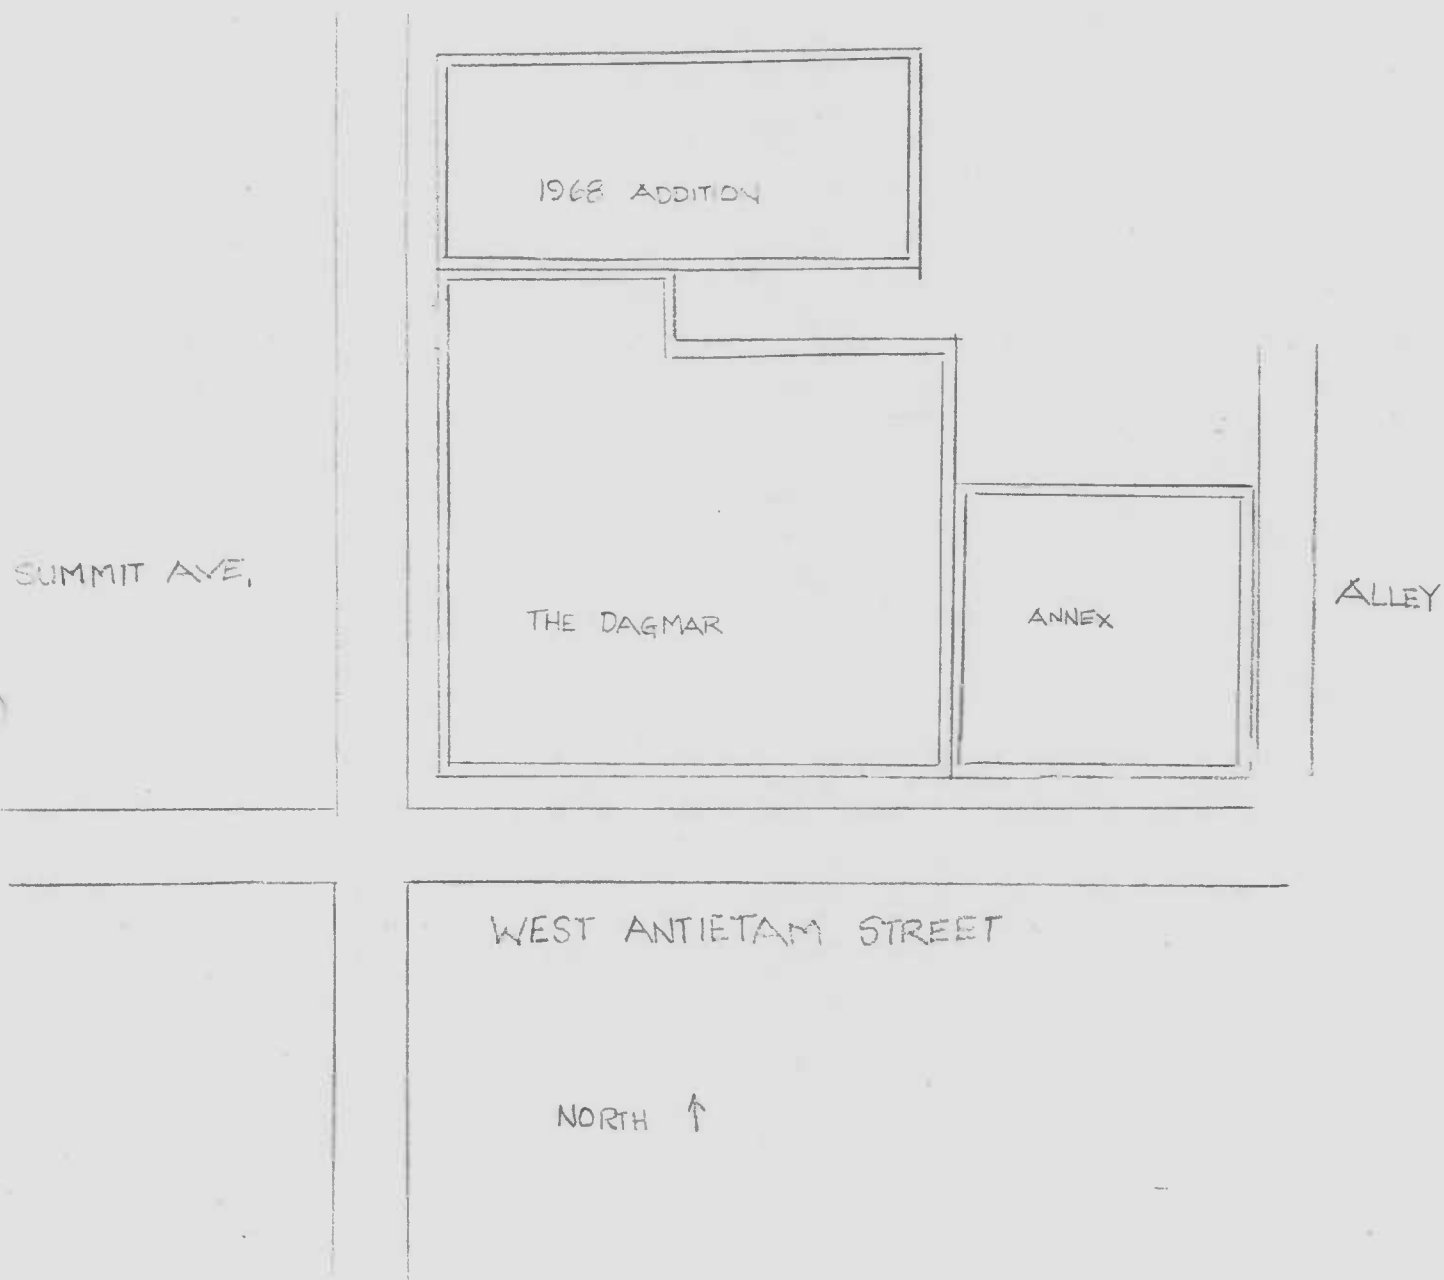
ROUGH SKETCH OF SITE PLAN

THE HOTEL DAGMAR

NOT IN SCALE!
